National Dam Inspection Program.

New Holland Reservoir Dam (NDI Number PA-00346, DER Number 36-241),

Susquehanna River Basin, Lancaster County, Pennsylvania. Phase I Inspection Report.

PHASE I REPORT NATIONAL DAM INSPECTION PROGRAM

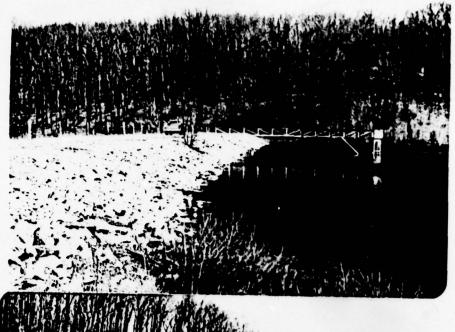
Upstream Slope and Intake Tower

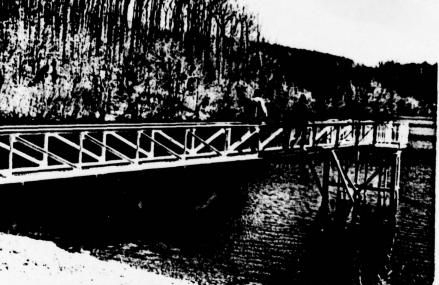
The operating facilities at this dam are in good condition. The footbridge leading from the crest of the dam to the intake structure appears sound. It is in the process of being painted on the date of this inspection. The three sluice gate controls are operable and appear to be well greased.

Footbridge to Intake Structure

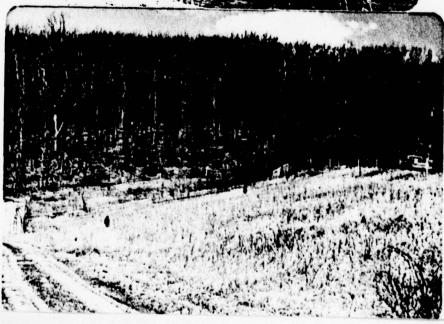
The downstream slope was essentially dry, even though some moisture was detected at the grassed surface. This is considered to be a normal condition as the result of heavy rains the day before this inspection. Low spots in the surface drainage swale along the toe of the embankment held some free water. This is also attributed to the previous day's rain.

One groundhog hole was observed on the downstream slope in the area of the trees. This should be filled.

Downstream Slope

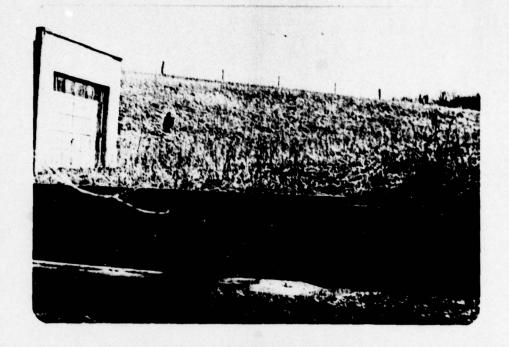
The outlet from the blowoff line (42-inch CMP) consists of an opening through the spillway outlet channel wall near its terminus. Refer to Appendix F, Plate IV. The condition of the discharge outlet in the wall is good.

Drawdown Pipe Outlet

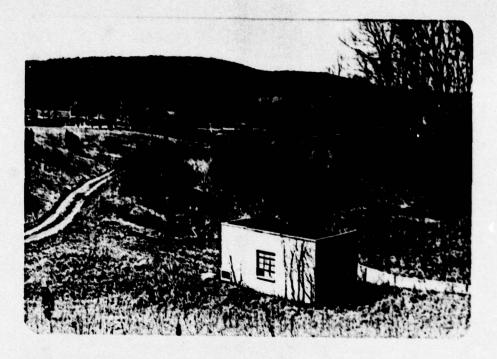
Downstream Channel & Valve House
